# **AAV IRAM TRANSMISSION REVIEW**

## **INTERIM REPORT TFLRF No. 334**

March 1998

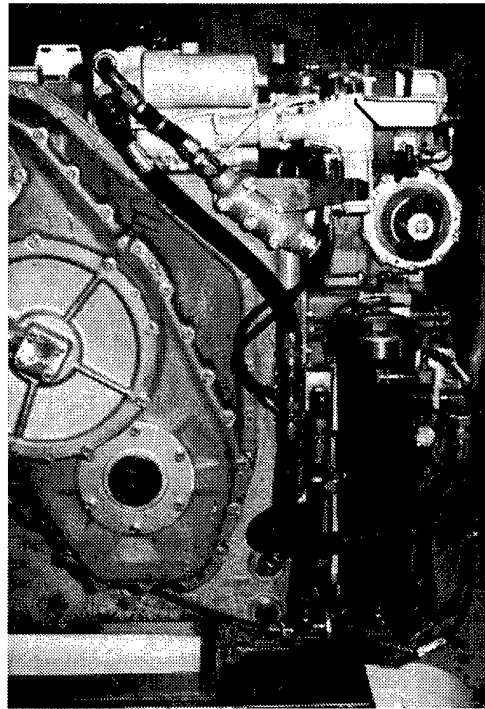
**Figure 4. Improved Filtration System**

The IRAM transmission has incorporated a new Parker filtration system, which improved the efficiency and load capacity of the older filtration system (Figure 4). The drawing for this system is shown in Figure 5. This filtration system efficiency is rated as being 50% efficient at 2  $\mu\text{m}$ ; 95 % efficient at 8  $\mu\text{m}$ ; and 98.7% efficient at 10  $\mu\text{m}$ . The apparent capacity for the Parker system is 200 grams. Based on past experience on other equipment with similar clearance (2), the critical particle size, which can cause significant damage, is approximately 6  $\mu\text{m}$ . Although the

Parker system has improved the filtration performance, for the ultimate practical protection, a 5  $\mu\text{m}$  filtration system should be investigated.
